RM No. E7L18

VIBRATION OF TURBINE BLADES IN A

TURBOJET ENGINE DURING OPERATION

By W. C. Morgan, R. H. Kemp and S. S. Manson

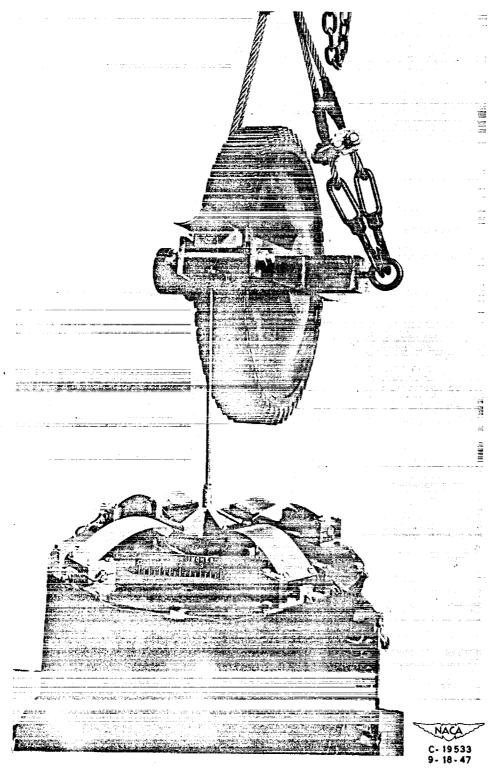
Figure 1. - Excitation equipment used in determination of nodes in turbine blade during various natural vibration modes.

Modes of vibration. - The nodal patterns in the various natural modes of vibration were determined by preliminary bench tests on a blade similar to those used in the dynamic investigations. In producing these patterns, the blade was inserted in a turbine disk with a tight fit in order to approximate the rigidity in a completely bladed wheel; vibration was excited by a speaker-type unit of variable frequency. In order to avoid mechanical damping or restraint of the blade, the excitation force was transmitted through a steel rod attached to a stub blade adjacent to the test blade in

the turbine disk. The turbine disk was suspended in a sling above the exciter (fig. 1).

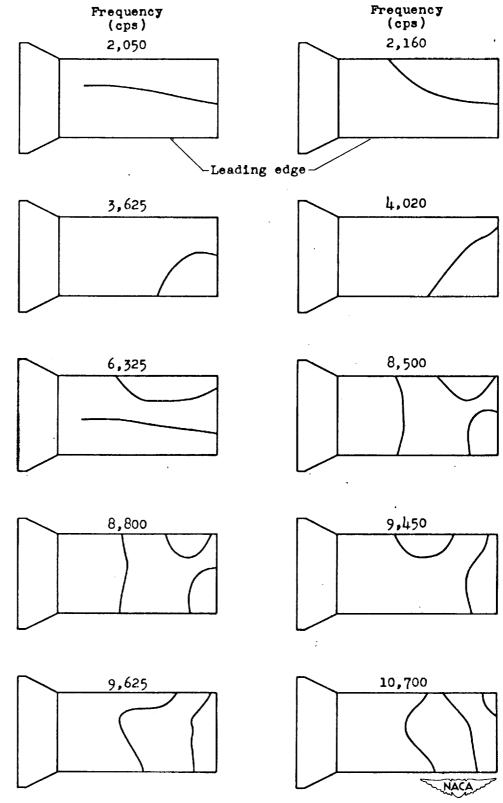
Figure 4. - Nodal patterns of 10 vibration modes determined. Fundamental frequency, 1270 cycles per second.

Nodal patterns were obtained on a blade of the same type as those instrumented with strain gages to determine the approximate frequencies of resonant vibration of the blades. The nodal patterns of 10 vibration modes that were excited by means of the

speaker-type exciter are shown in figure 4. The fundamental bending mode, not shown in the figure, occurred at a frequency of 1270 cycles per second. A point of interest was the similarity of the nodal pattern at 8500 cycles per second to that at 8800 cycles per second, a similarity apparently caused by the simultaneous occurrence of two modes mechanically coupled. Although similarity often exists among vibration nodal patterns at very high frequencies, the node patterns at 9450, 9625, and 10,700 cycles per second are dissimilar.

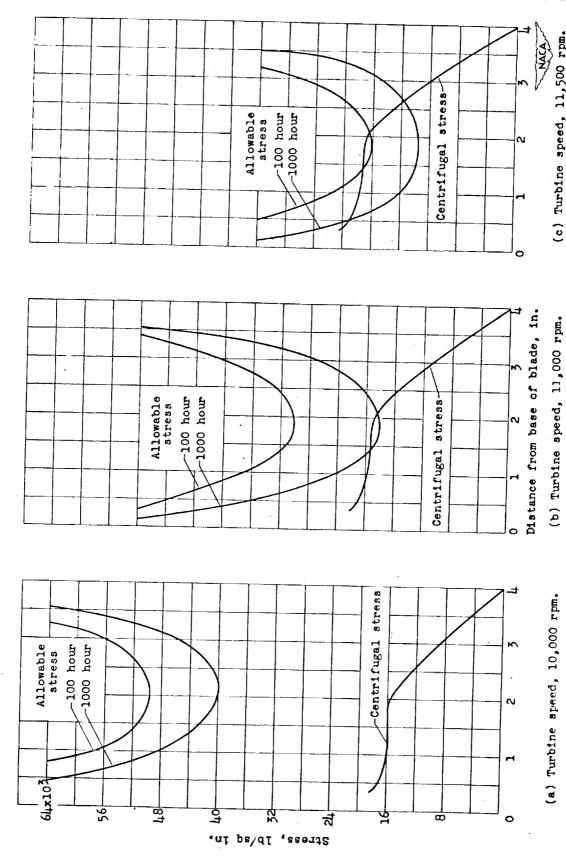
Figure 5. - Comparison between calculated centrifugal stress and allowable stress as computed from stress-rupture dats (c) Turbine speed, 11,500 rpm.

The centrifugal stresses in the blade at different speeds of operation were first computed in order to assist in the interpretation of the significance of the vibratory stresses. The results are shown in figure 5. The centrifugal stresses at various locations along the length of the blade are shown for turbine speeds of 10,000, 11,000, and 11,500 rpm. Bending stresses due to gas loading are not included in these calculations because the stress values are to be used only qualitatively. Also plotted in this figure are the allowable stress values at each location along the blade, based upon the temperature distribution in the blade (reference 2) and the stress-rupture values for Vitallium at each temperature for durations of 100 and 1000 hours. For speeds below 11,000 rpm, a margin of safety exists between the operating centrifugal stress and the stress-rupture values. At or above 11,000 rpm, little margin of safety exists at any location in the blade and even small vibratory stresses may be sufficient to precipitate fatigue failure.

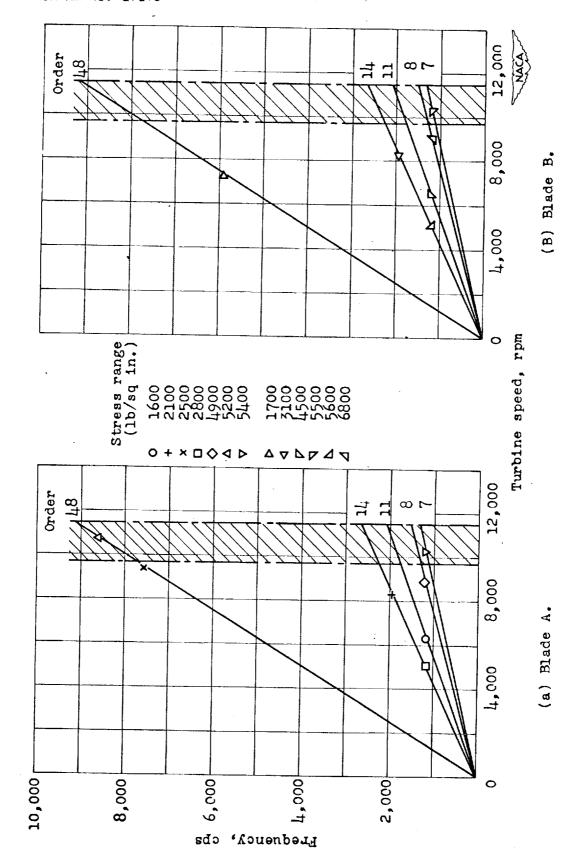
Shaded area indicates Figure 6. - Resonance spectrums showing occurrence of vibration. cruising range.

An analysis of the vibration data obtained on two of the blades is shown in figure 6. These blades were standard turbine blades mounted diametrically opposite. Each of the data points represents an engine speed at which vibration was observed and the frequency of the blade vibration. Also shown are a series of solid lines labeled order. Each of these lines represents the locus of points at which the frequency in cycles per second is a definite multiple of the frequency of turbine rotation in revolutions per minute. Such lines therefore define, at any engine speed, the frequency of any exciting force that occurs at a definite multiple of engine speed. For example, because there are 14 combustion chambers in this engine, an excitation due to the velocity profile of these combustion chambers would occur 14 times for every engine revolution. The frequency of combustion-chamber excitation at any

engine speed is therefore represented by the line for fourteenth order. A correlation between the observed points of blade vibration and the lines of multiple order is useful in ascertaining the sources of vibration excitation.

In addition to those points of sustained vibration shown in figure 6, several transient vibrations in the first bending mode at 1200 cycles per second were recorded near full-speed operation of the engine. These vibrations were recorded on the oscillograph film but were not visually identified on the oscilloscope screen. The duration of any of these vibrations was short, approximately 1/50 second; the cause of the vibrations was not ascertained. These vibrations could not be neglected, however, because of their occurrence at the speeds producing the greatest severity of temperature and centrifugal-stress conditions. Another point of interest not demonstrated in figure 6 was the absence of significant vibrations during a run in which the engine was accelerated from 4000 to 11,500 rpm within a period of 15 seconds while the oscillograph was continuously operated. Apparently sufficient damping existed to prevent the building up of vibration during rapid acceleration.

Inspection of figure 6 shows that the important orders of excitation are 7, 8, 11, 14, and 48. Excitations of the forty-eighth order are to be ascribed to the 48 nozzle blades in the turbine. In blade A, this source of excitation produced a stress range of 5200 pounds per square inch at a speed in the cruising range of the engine, where the temperatures are high and the margin of safety is low. The frequency of this vibration was 8600 cycles per second. Blade B was also excited by the forty-eighth order but at a different frequency, probably because of differences in the blade mounting. This vibration at a frequency of 5900 cycles per second did not occur within the cruising range.

The fourteenth-order excitation can be attributed to the 14 combustion chambers in the engine. This source produced first torsional vibrations at a frequency of 2000 cycles per second with a stress range of 2100 pounds per square inch in blade A and a stress range of 3100 pounds per square inch in blade B. Because the engine speed at which these vibrations occurred was below the cruising range of the engine, sustained vibrations due to this source are not likely and, moreover, they occur when the temperatures and the centrifugal stresses are relatively low so that greater vibrational stress is tolerable. The combustion chambers also produced fundamental bending vibrations at a frequency of 1170 cycles per second in both blades at a speed of approximately 5000 rpm but these vibrations are probably not of great importance because of the low speeds at which they occurred.

Vibrations due to eighth-order excitations may be of importance. Although these vibrations in the fundamental bending mode at 1200 cycles per second occur at a speed below the cruising range, their relative amplitude is high. In blade B, the highest vibratory stress range observed of 6800 pounds per square inch was excited by an eighth-order effect.

The seventh-order excitations, which are important, produced vibrations in the fundamental bending mode at a frequency of 1200 cycles per second. The stress range for both blades produced by this excitation was relatively high (about 5500 lb/sq in.) and occurred at a speed of about 10,300 rpm, which is within the cruising range of the engine and is accompanied by high blade temperatures and centrifugal stresses. Several possibilities exist as the source of this order of excitation. One of the more probable causes may be that inequalities of mass flow from the various combustion chambers produce numerous harmonics of engine speed and the lowest order that can excite blade vibrations at any speed within the operating range of the turbine is the seventh. Another possibility is that the response of the blade to excitation is nonlinear and would therefore tend to introduce a one-half-order excitation of the combustion chambers (reference 4).
